ASLA Brings Nature to its Roof

CHALLENGE: The American Society of Landscape Architects (ASLA) wanted a high profile location to demonstrate how landscape architects can play a central role in green roof design and construction. The organization decided to look no further than atop its own Washington, D.C., headquarters building—a black tar surfaced roof on the 11-year-old brick building.

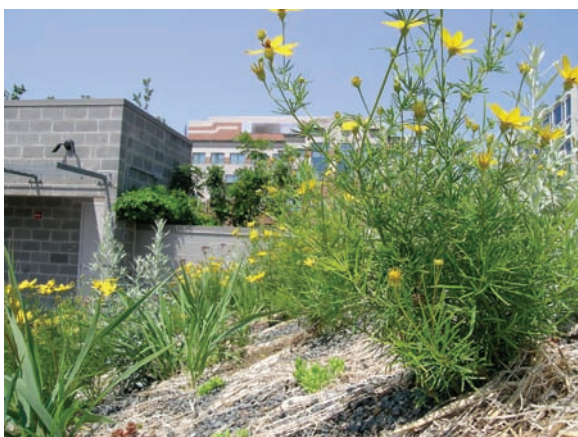
DEMONSTRATION ROOF

The American Society of Landscape Architects decided its own roof would make an excellent demonstration model
